GEOMORPHOLOGY AND GEOTECHNICAL CHARACTERIZATION OF THE QUEENSTOWN HILL LANDSLIDE

A thesis submitted in partial fulfilment of the requirements
for the Degree of

Master of Science in Engineering Geology

University of Canterbury
School of Earth and Environment

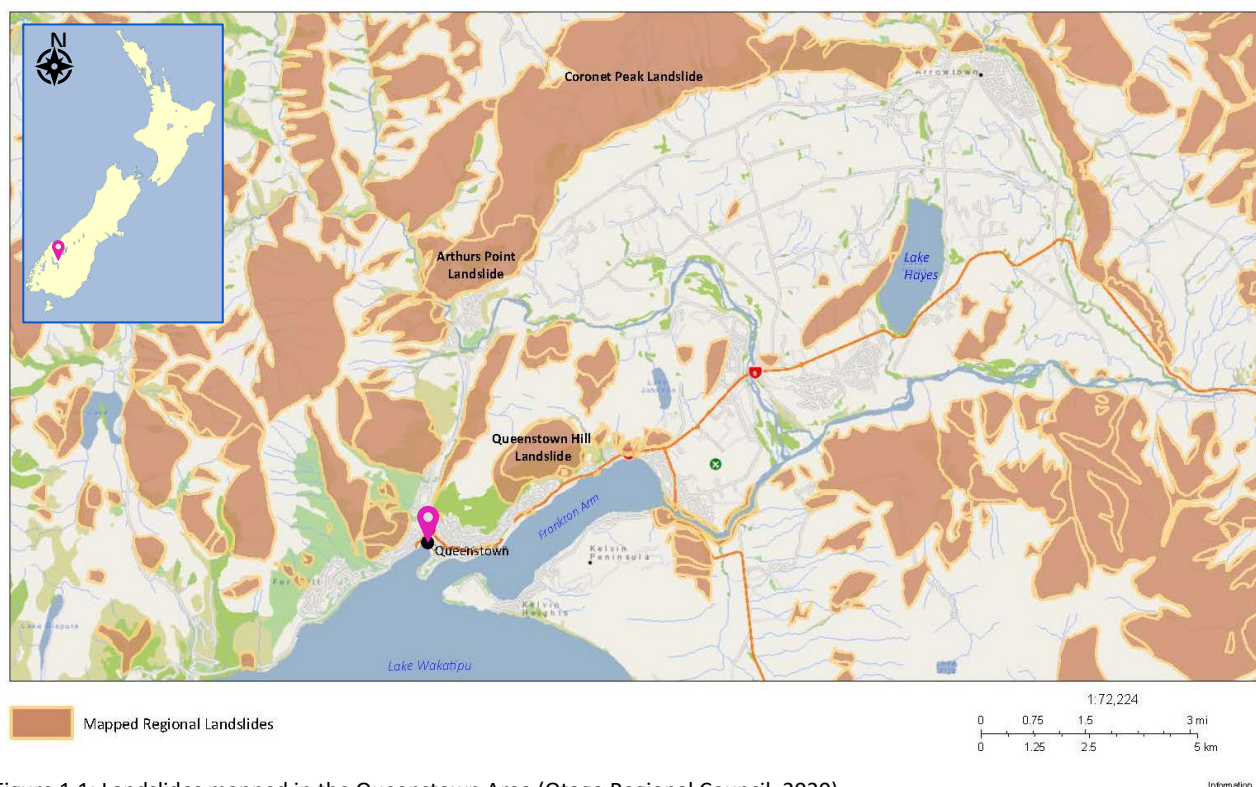
Figure 1.1: Landslides mapped in the Queenstown Area (Otago Regional Council, 2020).

The slopes surrounding the Queenstown area are predisposed to instability, as shown by several deep-seated bedrock landslides (Figure 1.1). Proposals to develop along the landslide margins is increasing, as many existing developments on the landslides have not experienced damage relating to slope movement (Bell, 1996a, b, 2018; Bell and Riddolls, 1992). For example, the Coronet Peak Skifield has been developed on the hummocky upper slopes of the Coronet Peak Landslide, as well as the associated infrastructure (including roads, buildings, chairlift towers and snowmaking ponds) (Bell, 2007a, b, 2008a, b, 2009; Philp, 2011). However, the pressure for residential expansion has led to more intensive subdivision development proposals on the lower slopes of the Queenstown Hill Landslide (Bell, 2018; Bell and Pettinga, 1985; Bell and Riddolls, 1992).

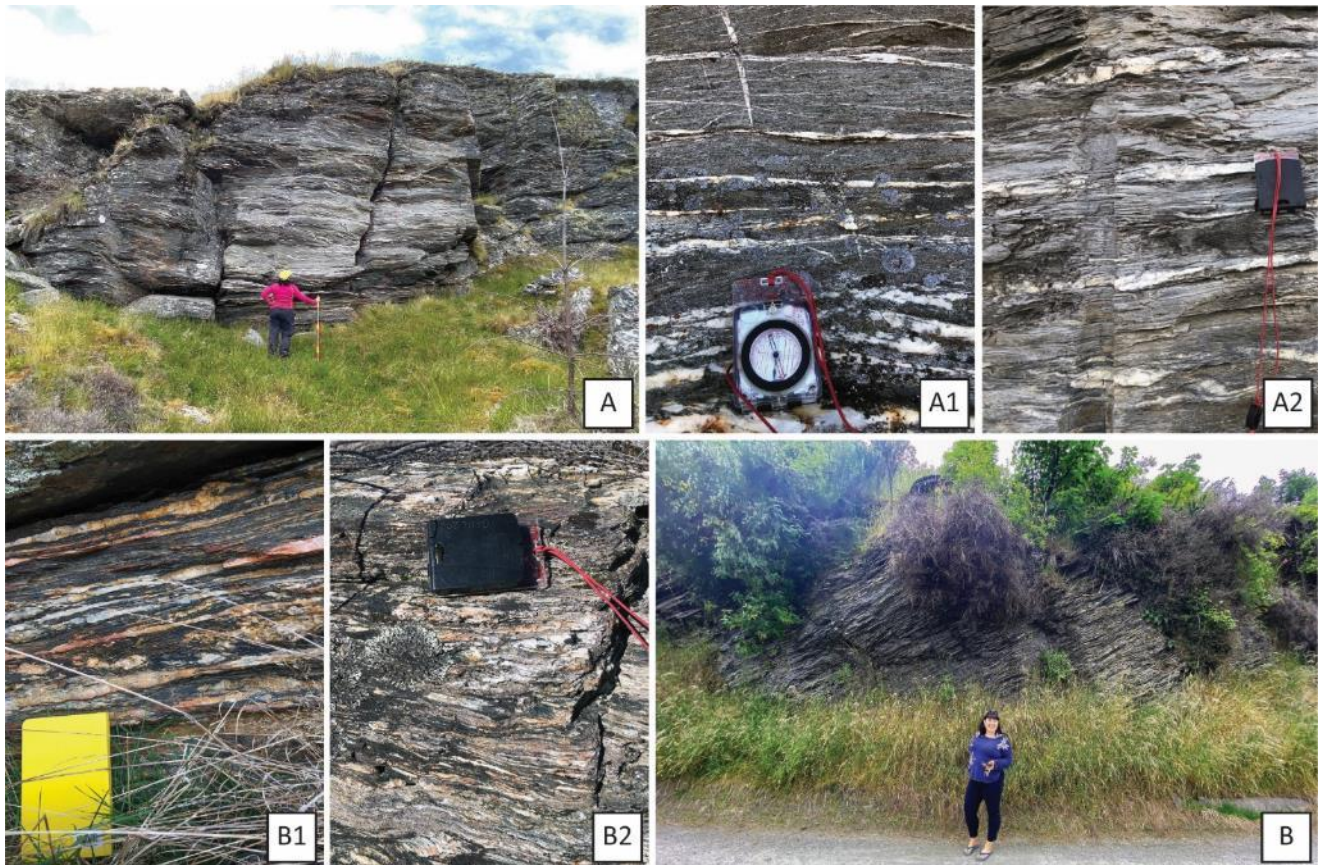
Figure 2.9: Photos of the medium grey (A, A1, A2) and dark green-grey (B, B1, B2) schist at outcrop scale. A: typical appearance of the medium grey schist in outcrop. The schist is relatively smooth, with well formed discontinuities. A1,A2) A1 was taken within the landslide. A2 is outside the landslide boundary in a subdivision road cutting - note drill hole from blasting. The thick quartz segregations are visible between the homogenous <1mm thin mafic foliations. B) typical appearance of the dark green-grey schist in outcrop. The schists surface roughness is due to preferential weathering of mafic layers in the undulating foliation. B was taken outside the landslide boundary along the Frankton Walkway. B1, B2) Both photos were taken within the landslide. The mm-cm scale undulating dark and light segregations are visible. Discontinuities are not as well developed and stepped/rough.

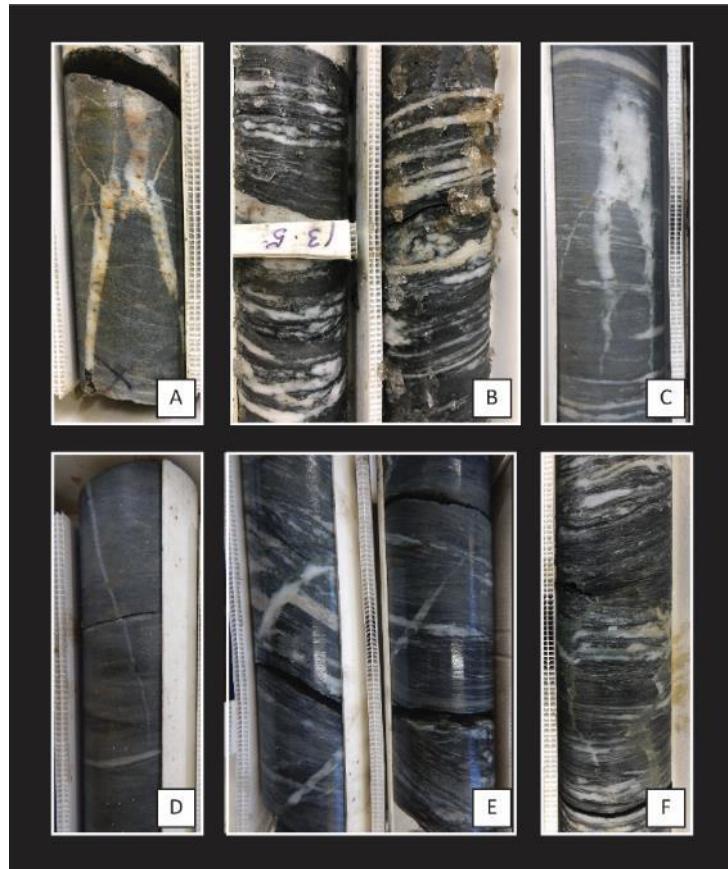
Figure 2.16: A) Upright, symmetric similar fold with limbs dipping at 70°. B) Multiple folds visible in the quartz/plagioclase veins. Photo C) Folded quartz with chlorite. D) Very steeply inclined (70°) 1-3mm quartz vein in MGy schist. E) 55° Quartz vein cross cutting quartz/plagioclase segregation and foliation. F) 1-5mm thick upright folded chlorite.

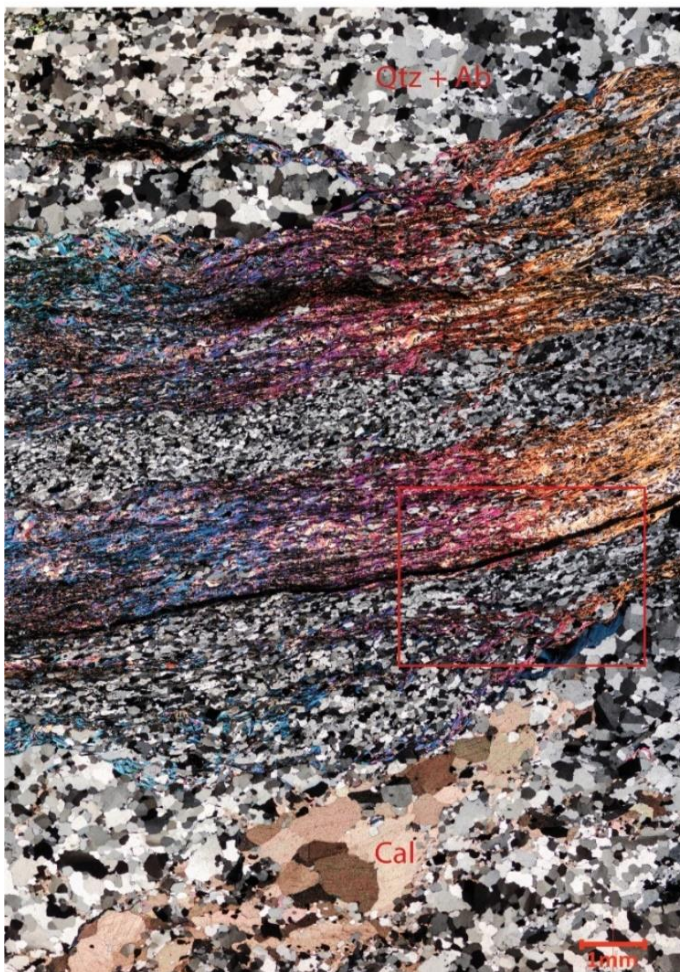
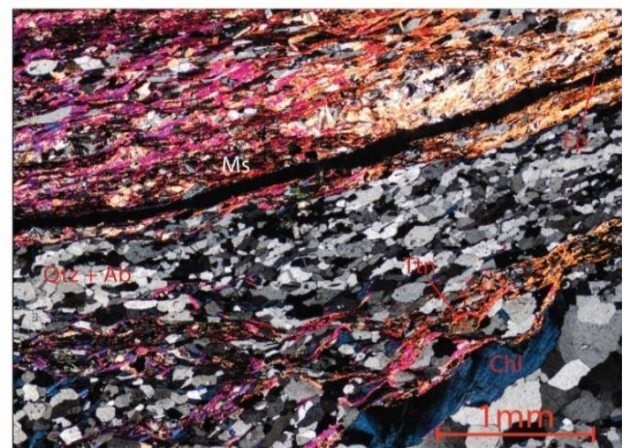
Figure 2.17: Stitched XPL photos of multiple thin section showing the differences in compositional layering and segregation thickness between the MGy and DGy lithotypes. (Photo credit: Kamen Engel)

The lithotypes were analyzed to ascertain their mineral composition and textures, then presented in Table 2.6 and Table 2.7 respectively. A series of thin section photos were then stitched together to show the difference in compositional layering (Figure 2.17).

Based on their mineral composition, the MGy and DGy schist lithotypes are part of the chlorite zone of the greenschist facies (Hollocher, 2014; Raymond, 1995; Yardley, 1989). Two distinct assemblages were recognized: (1) quartz-albite-epidote-chlorite \pm muscovite-titanite-calcite (MGy) and (2) albite-quartz-muscovite-chlorite \pm epidote-calcite (DGy). Based on the proportions of quartz, mica and carbonate minerals, the MGy schist can be identified as a quartzofeldspathic psammitic schist, and the DGy schist a semi-pelitic schist according to the ternary diagram from Barker (1998) (Figure 2.18). The metamorphic textures present in both lithotypes share many similarities, but they can be clearly identified by their differing fabric and compositional layering. The MGy schist has a poorly developed foliation with a more homogenous appearance. Many minerals are overlapping, compositional bands rarely exceed 800 μ m, mm-scale bands are more likely to be infilled quartz-albite veins. The DGy schist is intensely foliated with a compositional layering that resembles gneissose texture. The compositional bands are parallel, mm-scale, well segregated with relicts of the original bedding present.

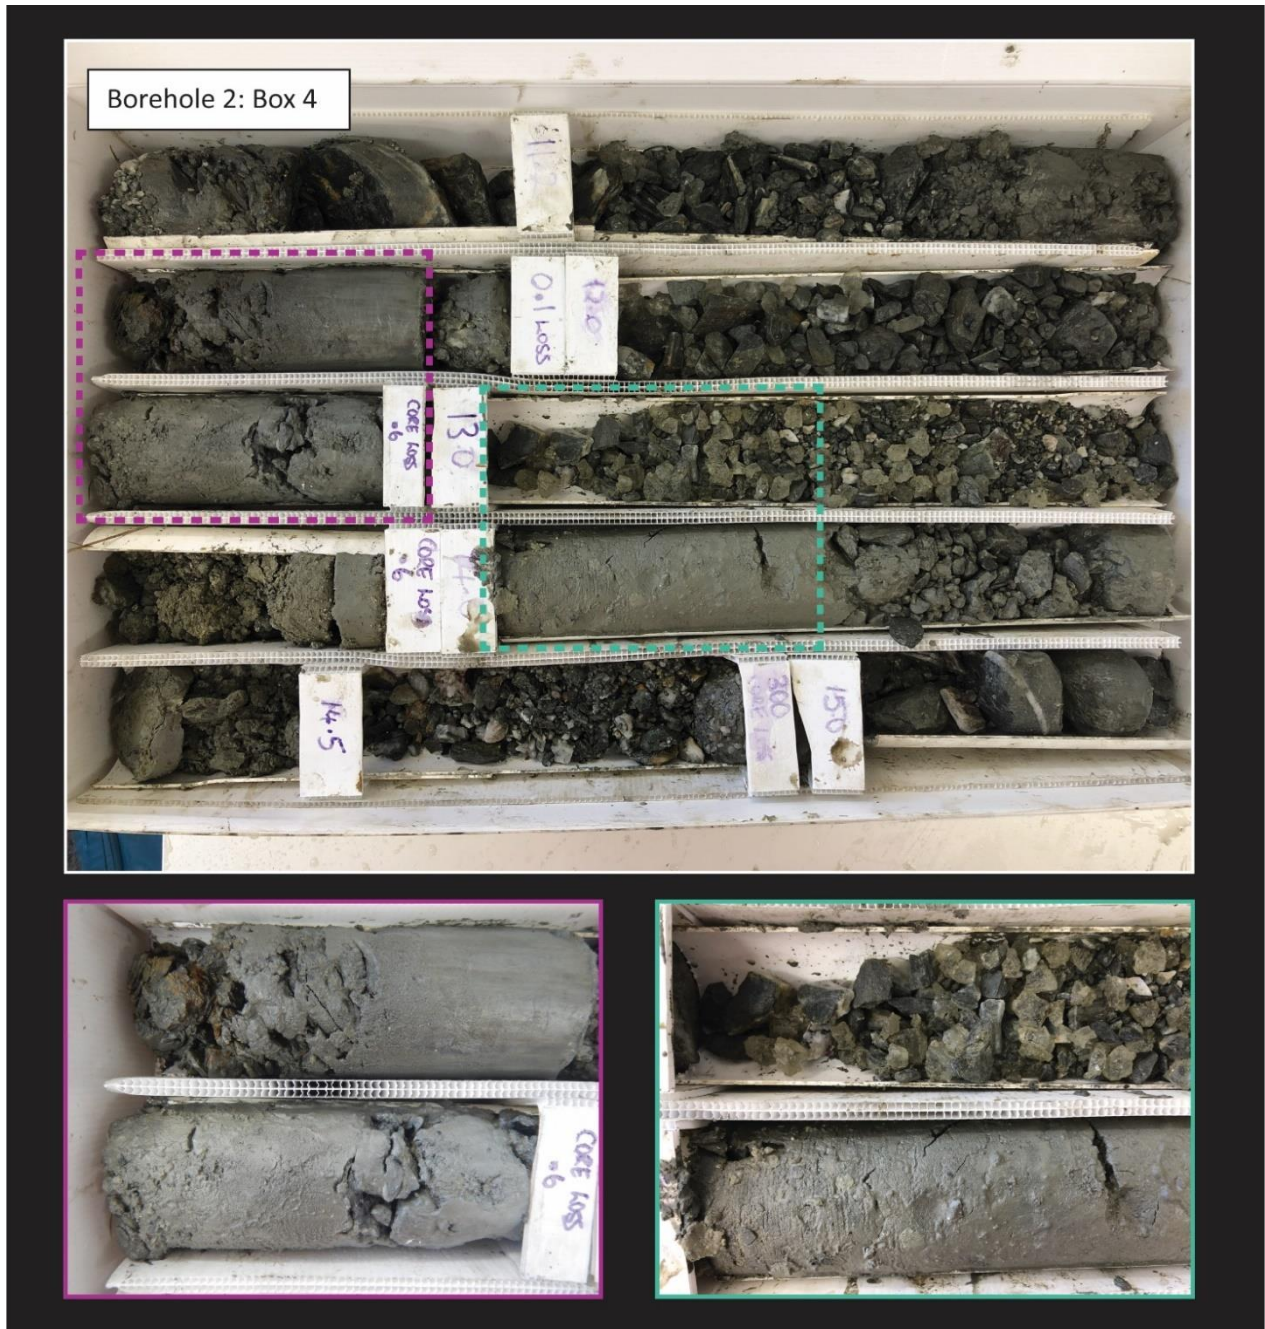
Figure 2.22: 10-30 cm sequences of silty clay with minor sand and fine to coarse gravels. The silty clay is silver and taupe, homogeneous, moderately densely packed, soft, moderately graded and highly plastic. Adjacent to the clay layers are 10-30 cm sequences of loose sandy gravels with traces of sand and clay.

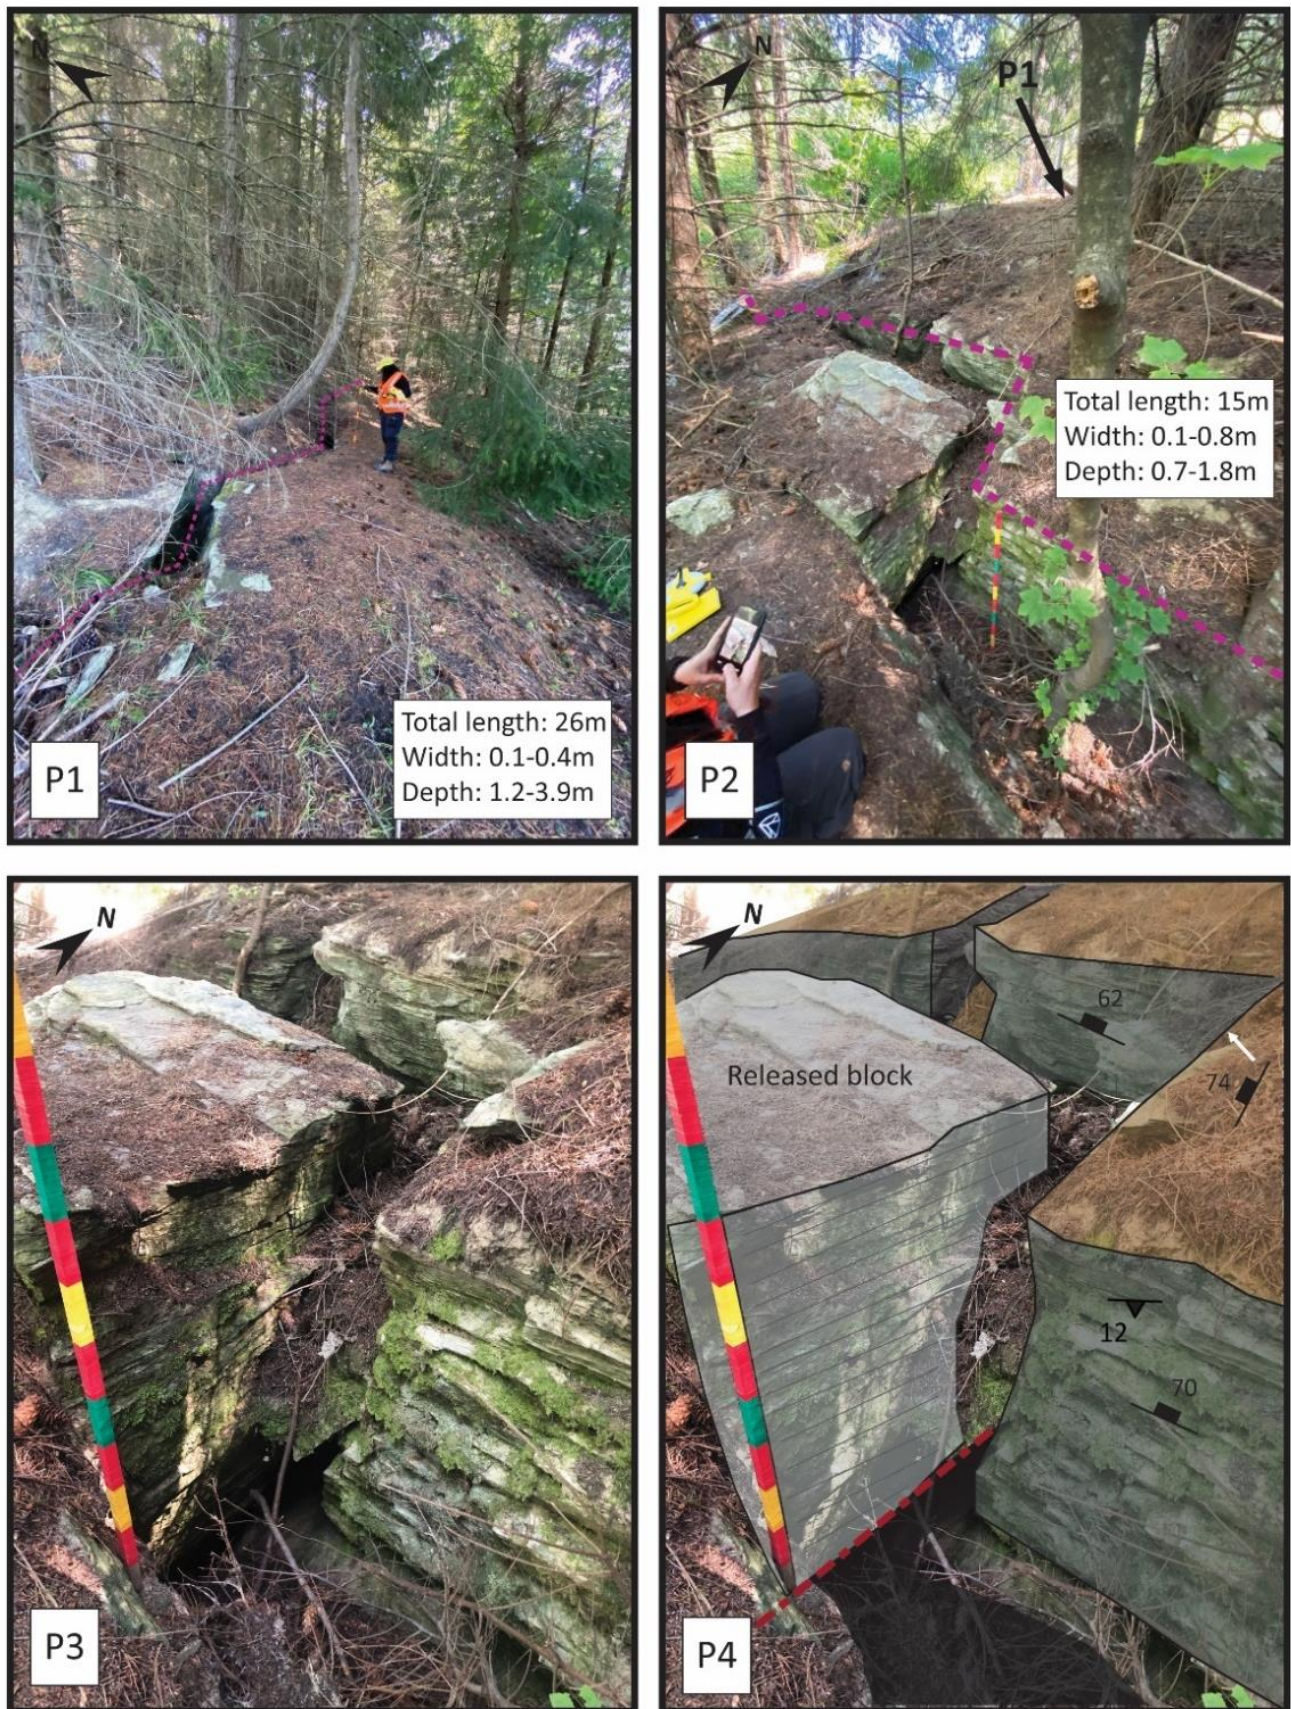
Figure 3.14: (P1) Alternate view of (P) from Figure 3.13. (P2) is the third fracture in a series of parallel fractures that continue downslope. (P3, P4) The released block slid along foliation and the identified joint sets provided a releasing surface.

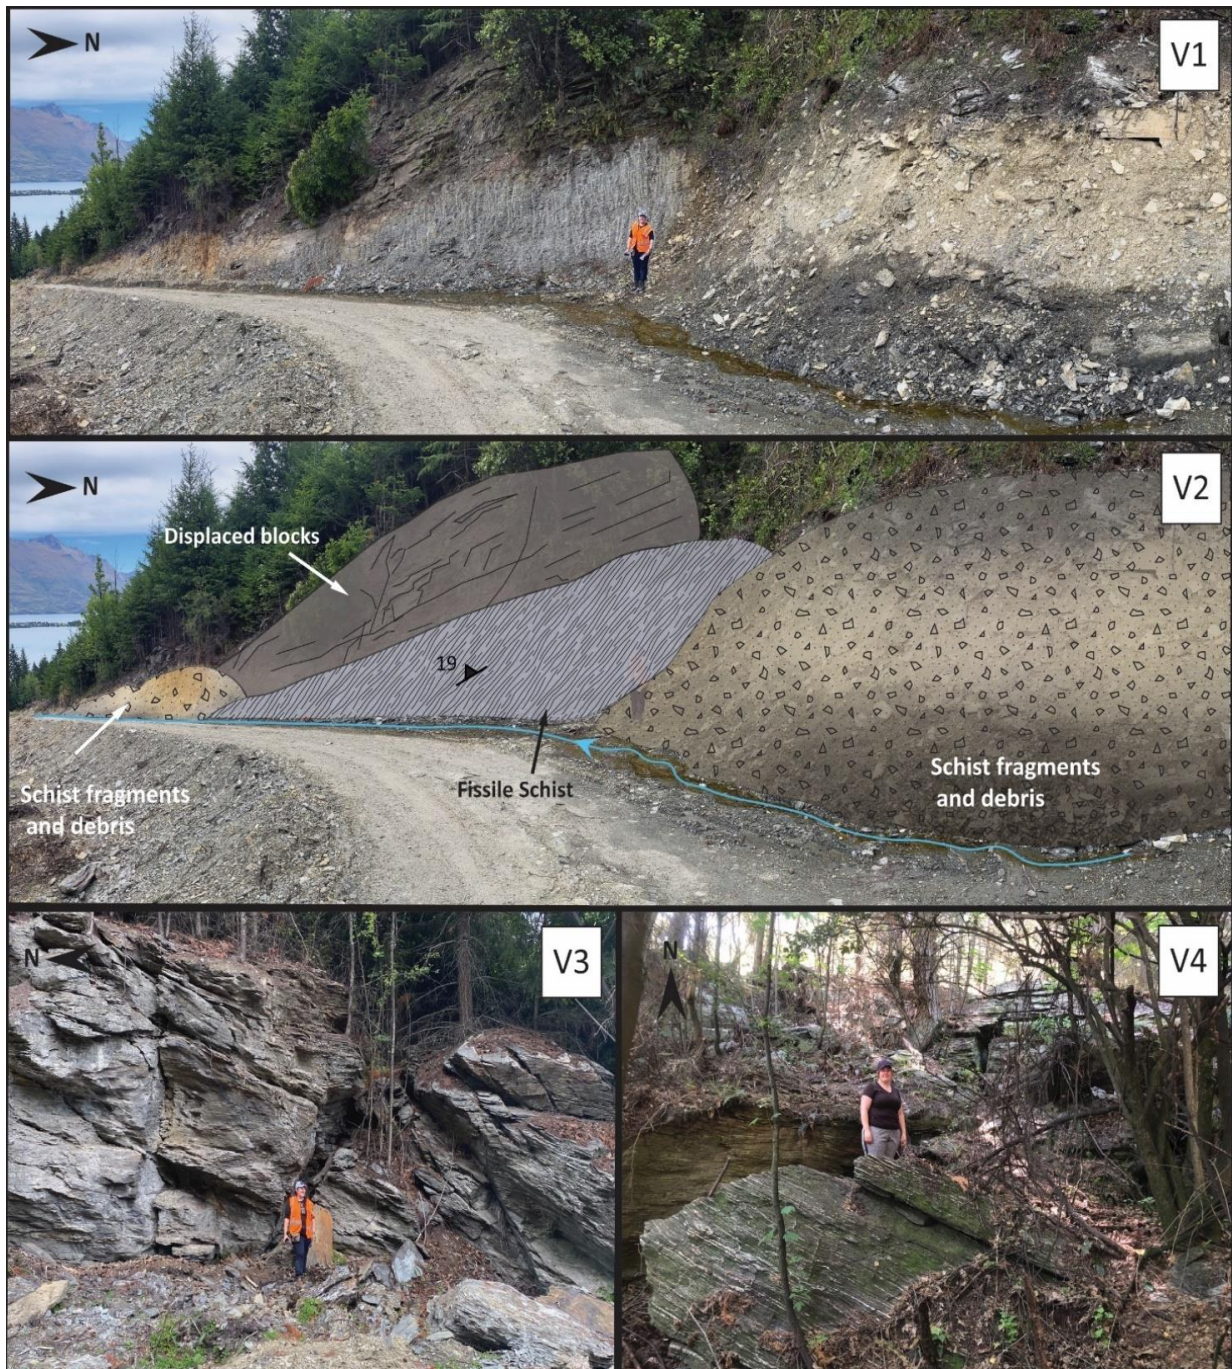
Figure 3.18: (V1,V2) Cross section view of an excavated portion into the compressional lobe at the base of Zone D. This area is also included as part of the overall toe zone, due to its compressional nature at the base of the slope. Chaotic debris piles are mapped along the base of all compressional features across the landslide with drainage flowing along the outer edges. (V3) Displaced blocks on top of a compressional lobe exposed by tree clearing and excavation. (V4) Chaotic block mound along the margins of a compressional lobe.

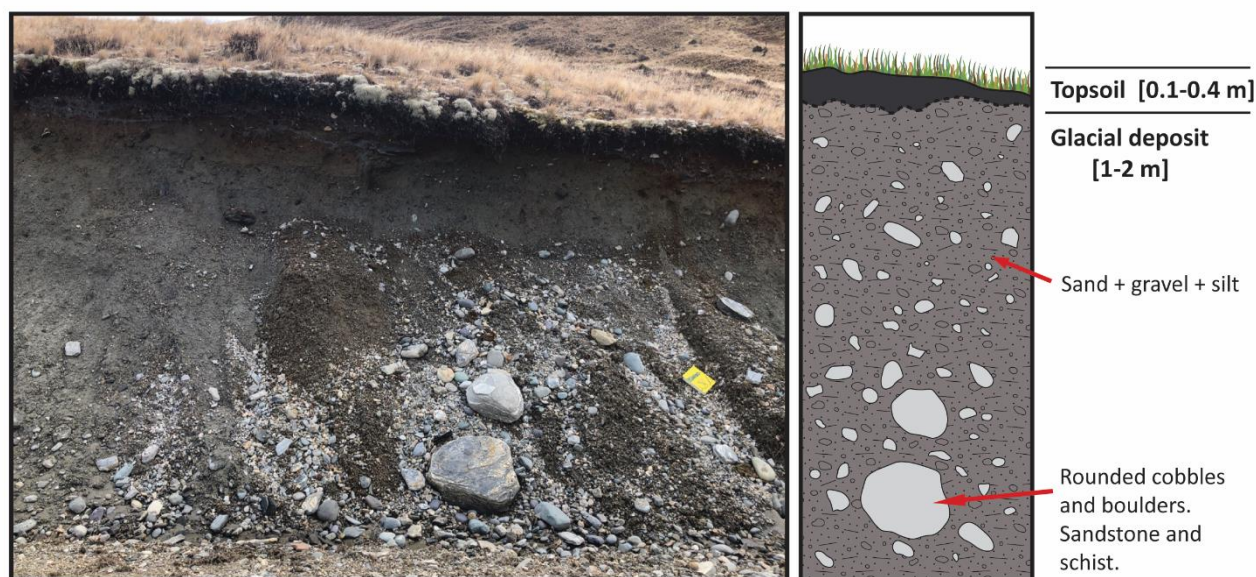
Figure 3.23: 1-2 m exposed glacial deposits in track cuttings along the top of Queenstown Hill. Silty sandy GRAVEL with cobbles and boulders. Cobbles and boulders up to 0.8 m in diameter are made up of Caples group sandstone and schist.

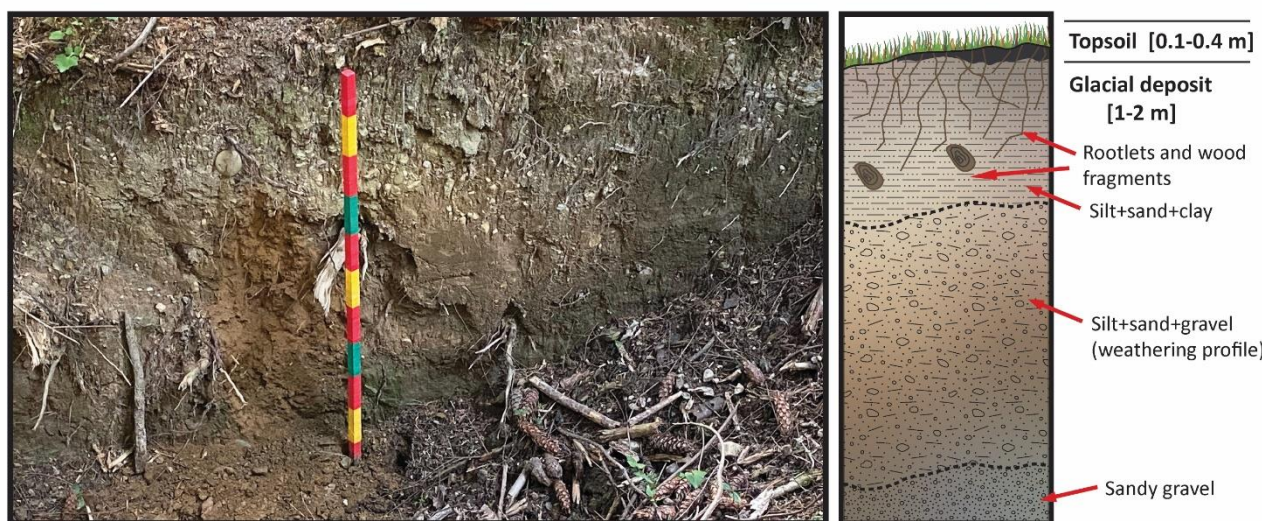
Figure 3.24: 1 m exposed glacial deposits in excavated area along the lower portion of the landslide. Gravelly SAND with silt with exposed post glacial weathering profile.

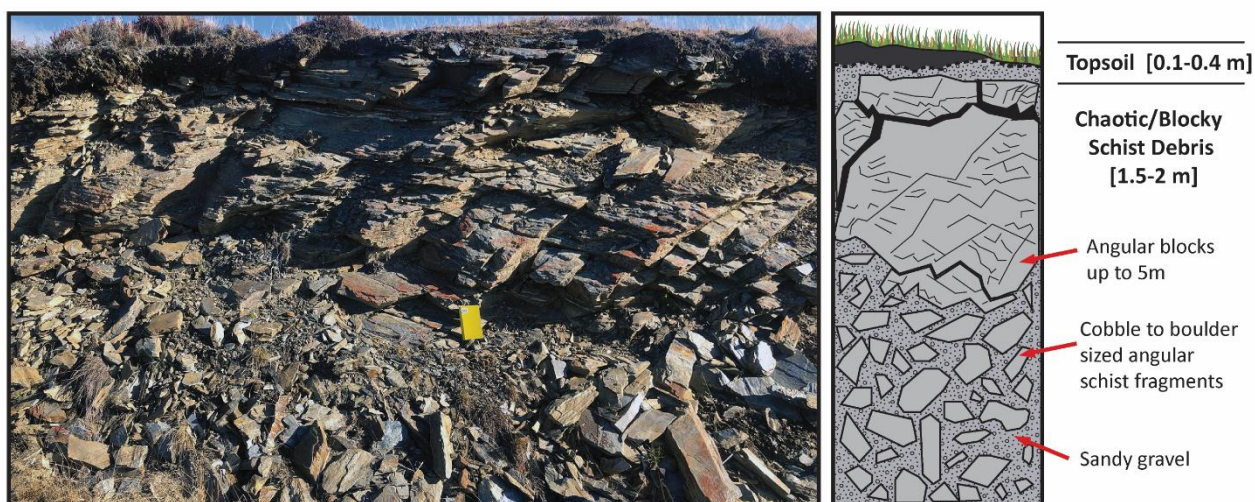
Figure 3.26: 2 m exposed chaotic/blocky schist debris in track cutting at the top of the landslide. Large displaced fractured block in a matrix of angular cobbles and sandy gravel.

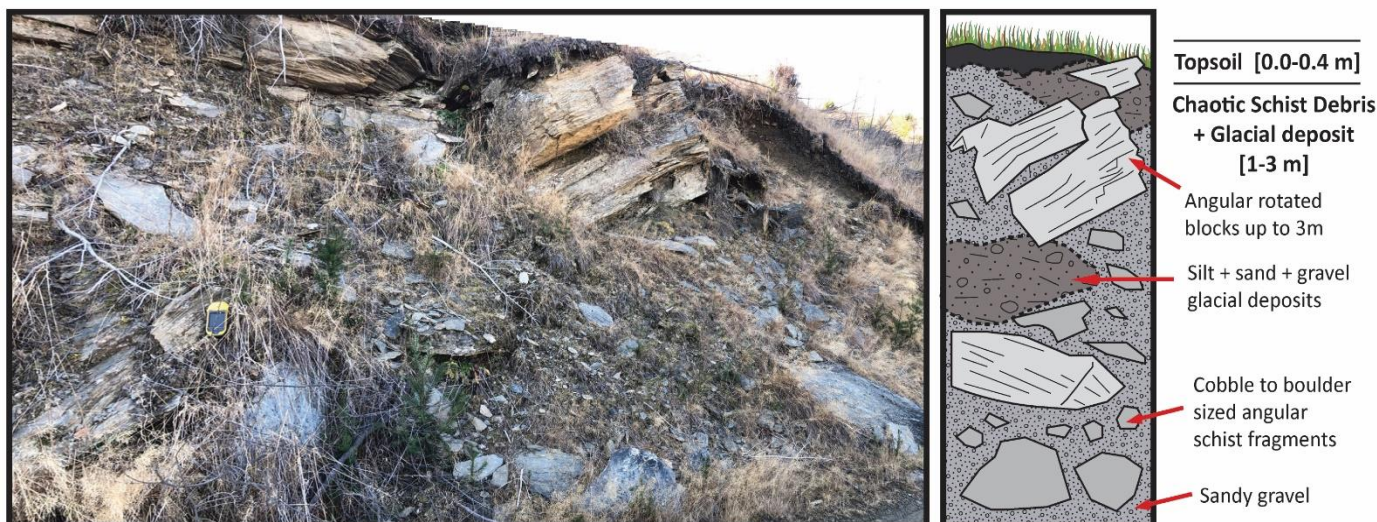
Figure 3.27: 3 m exposed chaotic/blocky schist debris in track cutting within the landslide. Large (2m) rotated schist blocks in a matrix of angular cobbles, sandy gravel, and glacial material.

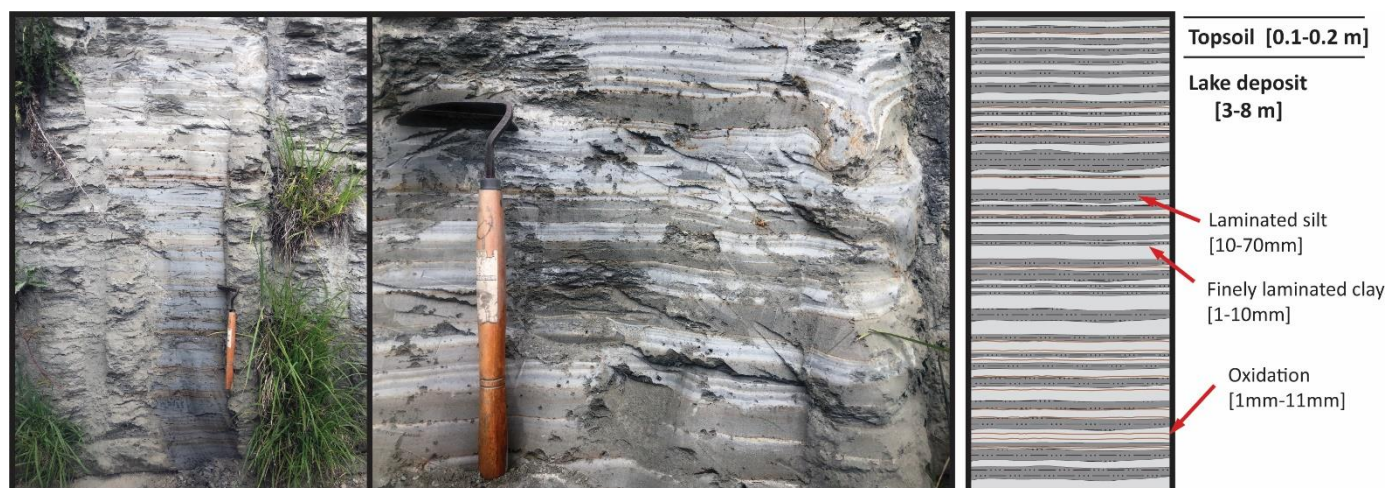
Figure 3.29: 3 m bench of exposed lake deposit in road cutting along SH6.

Lake deposits (lake bottom sediments) (Figure 3.29) were mapped in the road cutting, along State Highway 6 (Kingston Rd.), on the south side of the Kawarau River. The deposit is made up of horizontal layered, interbedded micaceous silt and clay. Laminae thickness ranges from > 1mm to 70 mm, increasing with depth. Oxidation occurs predominantly along clay beds and is 1-11 mm thick. The deposit is described as :

clayey SILT with traces of sand; light and dark grey, subhorizontal and interbedded. Densely packed; firm to very stiff; dry; uniformly graded; no plasticity; thick; slightly to moderately weathered

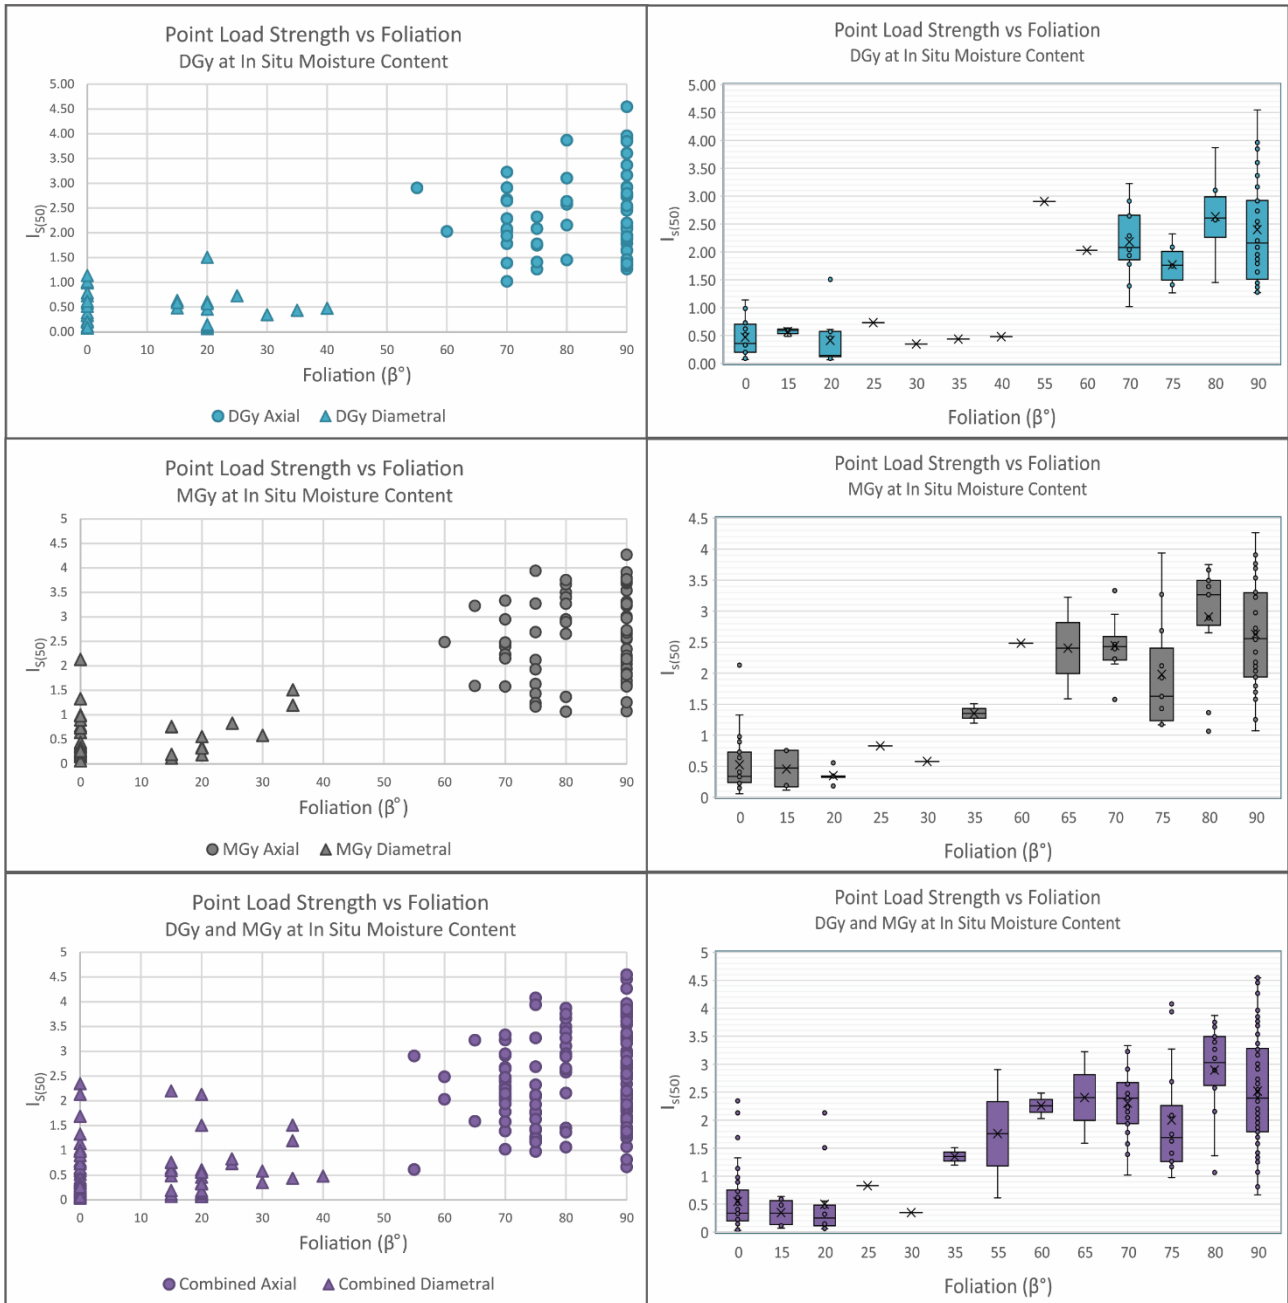
Figure 4.8: Plots showing the relationship between foliation orientation and point load strength for each lithotype (left) and box and whisker plots showing the distribution of the samples (right).

The point load strength index values (corrected for 50 mm) of the DGy and MGy schist and foliation angles tested at in situ moisture content are summarized in Table 4.12 and Figure 4.8. Oven dried specimen test results are presented in Appendix C.2 along with Individual sample information and graphs. The tabled data is presented by lithotype, orientations of the tested specimens and includes a column combining both lithotypes. The β -angle represents the orientation of the foliation relative to the point load platens. These results are presented separately as: 1) samples tested perpendicular and parallel to foliation; 2) an amalgamation of all samples tested oblique to foliation (range: 50°-80° and 10°-35°) and 3) samples tested at 70°-75° and 15°-20° separated out from the amalgamated range. The results were kept separate to allow for consistency when applying conversion factors (such as the UCS conversion factor), as none of the UCS, triaxial strength or indirect tensile strength samples were tested perpendicular or parallel to foliation.

The average point load strength index values derived from axial testing of the DGy schist range between 2.08-2.40 MPa and mean values derived from diametral testing were 0.46 MPa. A conversion factor (K) for UCS was calculated as $K = 10.6$ for samples loaded at 50°-80°. However, this increased to 14.4 when only considering samples oriented from 70°-75° (or 15°-20° from horizontal). The average point load strength values measured for the MGy schist were higher than the DGy with means ranging between 2.18-2.63 MPa for axial loading and between 0.40 and 0.61 MPa for diametral loading. Both lithotypes share a similar trend: during axial testing the strength decreases, as the foliation angle decreases from perpendicular towards 40° for diametric testing the strength increases, as the foliation increases from parallel

An overall conversion factor (K) for UCS was calculated as $K = 18.6$ however, this increased to 23.2 when only considering samples oriented from 70°-75° (or 15°-20° from horizontal). The variability (10.6-23.2) of the UCS correlation factor (K) derived from testing suggests care should be taken when recording the foliation orientation relative to loading direction to convert to UCS and that applying a conversion factor of 23.7 (Broch and Franklin, 1972) may result in overestimation of the UCS.
